BUCKNAR'S MARKET
(Walter's Grill)
209-211 East Main Street
Waterloo
Seneca County
New York

HABS No. NY-6328

HISTORIC AMERICAN BUILDINGS SURVEY

Location: 209-211 East Main Street (State Route 5/U.S. Route 20),
Waterloo, Seneca County, New York

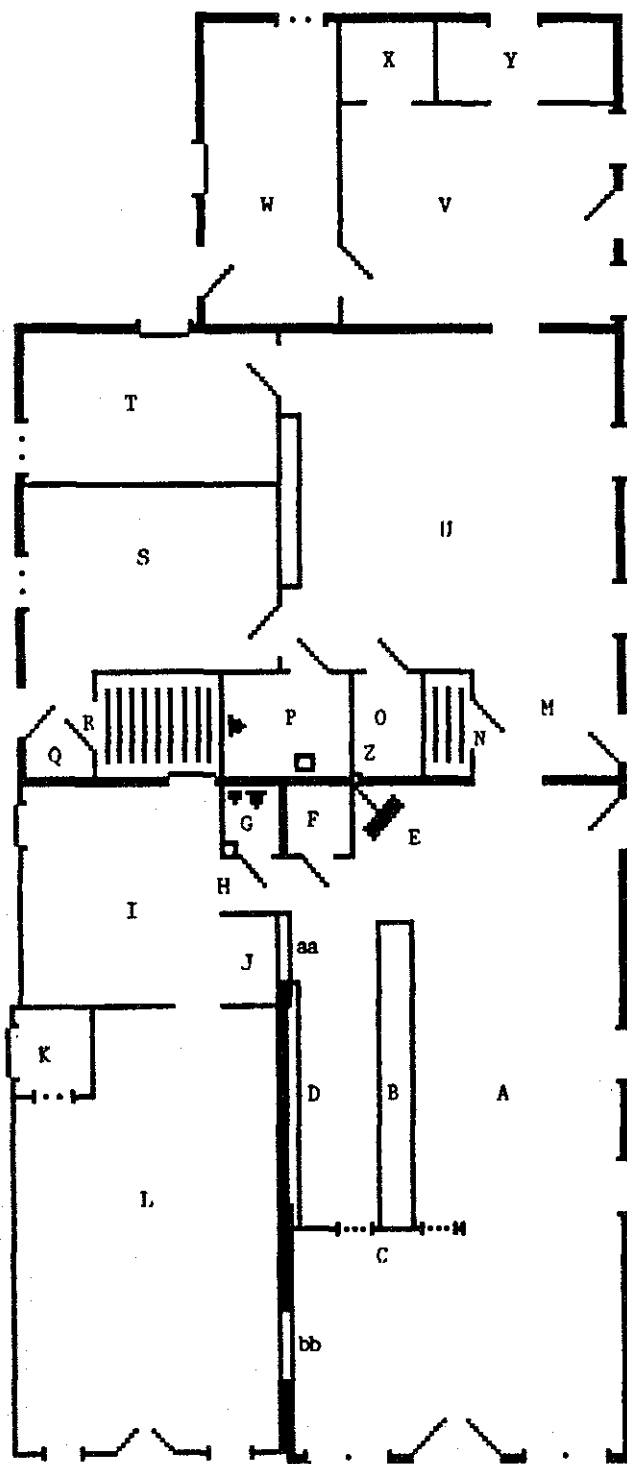
FIRST FLOOR PLAN

- A - Saloon (35'3-1/2" N-S;
17'1-1/2" E-W)
- B - Bar (18' N-S; 2'4" E-W)
- C - Room Divider (10' E-W)
- D - Bar Shelf (14' N-S)
- E - Stove
- F - Closet (4'2" N-S; 4'2" E-W)
- G - Men's Toilet Room (4'2" N-S;
5'10" E-W)
- H - Hallway (3'4-1/2" N-S;
7'2" E-W)
- I - Storeroom (12'1" N-S;
9'5-1/2" E-W)
- J - Closet (3'6-1/2" N-S; 6'2" E-W)
- K - Alcove (5' N-S; 5' E-W)
- L - Market (23'7" N-S; 15'6" E-W)
- M - Alcove (4' N-S; 7'7" E-W)
- N - Stairway - down
- O - Closet (not measured)
- P - Women's Toilet Room
(3'7" N-S; 7'11" E-W)
- Q - Entry Alcove (4' N-S; 4'1" E-W)
- R - Stairway - up (3'7" N-S)
- S - Room (10' N-S; 15'1" E-W)
- T - Storeroom (9' N-S; 15'1" E-W)
- U - Dining Room (19'8-1/2" N-S;
18'10" E-W)
- V - Kitchen (12'5" N-S; 14'5" E-W)
- W - Storeroom (17' N-S; 7'11" E-W)
- X - Closet (4'5" N-S; 5'4" E-W)
- Y - Pantry (4'3" N-S; 8'8" E-W)

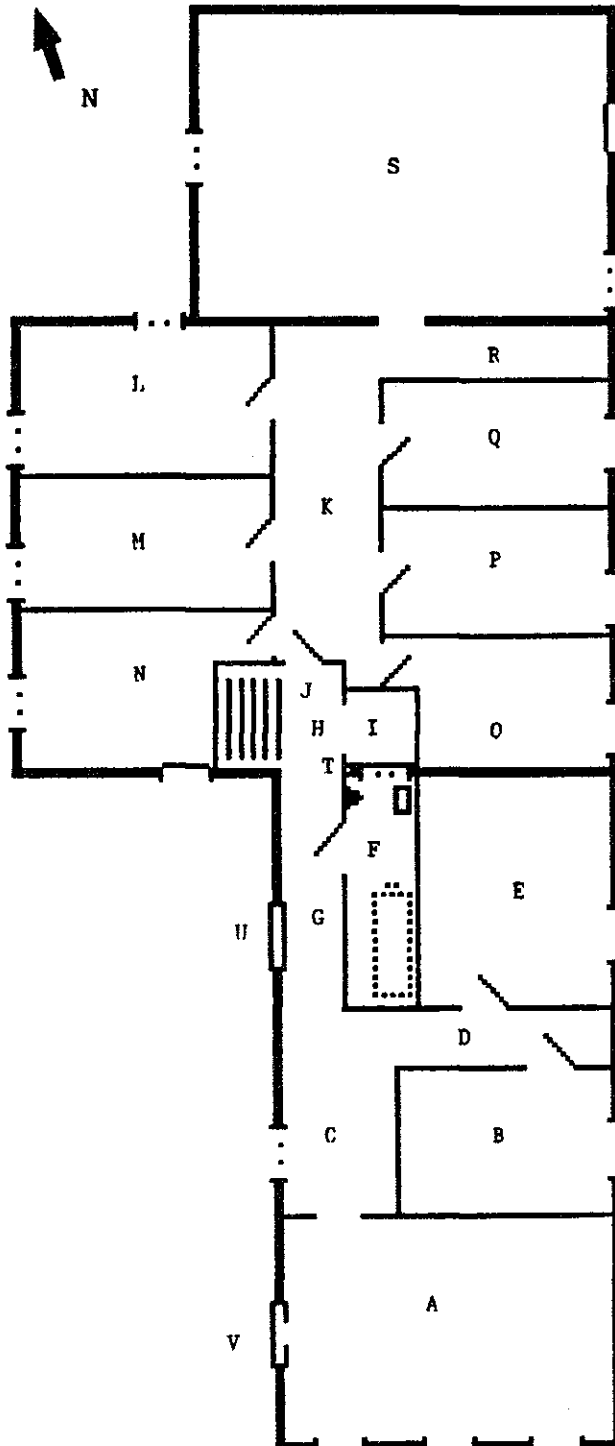
SECOND FLOOR PLAN

- A - Front Parlor (18'1" N-S; 12'9" E-W)
- B - Bedroom (7'9" N-S; 12' E-W)
- C - Front Hallway (11'1" N-S; 5'8" E-W)
- D - Center Hallway (3'1" N-S; 12' E-W)
- E - Bedroom (11'3" N-S; 10'6" E-W)
- F - Bathroom (11'2" N-S; 3'6-1/2" E-W)
- G - West Hallway (17'8" N-S; 3'3" E-W)
- H - Landing (3'7" N-S; 3'3" E-W)
- I - Closet (3' N-S; 3'6-1/2" E-W)
- J - Stairwell down (3'7" E-W)
- K - North Hallway (not measured)
- L - Bedroom (not measured)
- M - Bedroom (not measured)
- N - Bedroom (not measured)
- O - Bedroom (not measured)
- P - Bedroom (not measured)
- Q - Bedroom (not measured)
- R - Back Hallway (not measured)
- S - Rear section (not measured;
floor plan not known)
- T - Chimney
- U - chimney
- V - Chimney with Fireplace

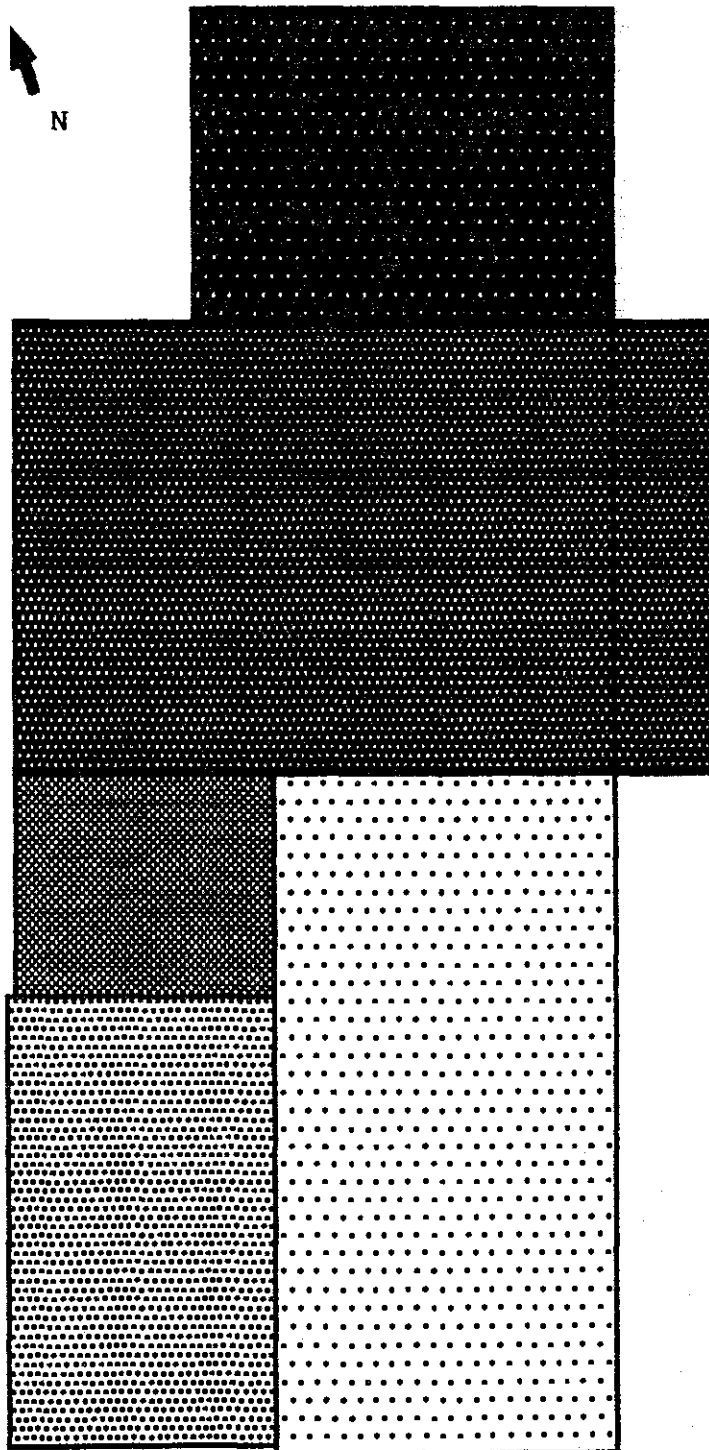
BUILDING WINGS AND DATES

Rear Wing
(after 1875)
-

Middle Wing
(ca. 1870-73)
-

Rear Market Addition
(after 1873)
-

Market
(ca. 1873-75)
-

Saloon
(ca. 1866-1870)
